Cultural Resources Survey of the Clements Ferry Road Widening Project Berkeley County, South Carolina

Addendum Report

Joshua N. Fletcher and Rachel Bragg
Brockington and Associates, Inc.

April 2017

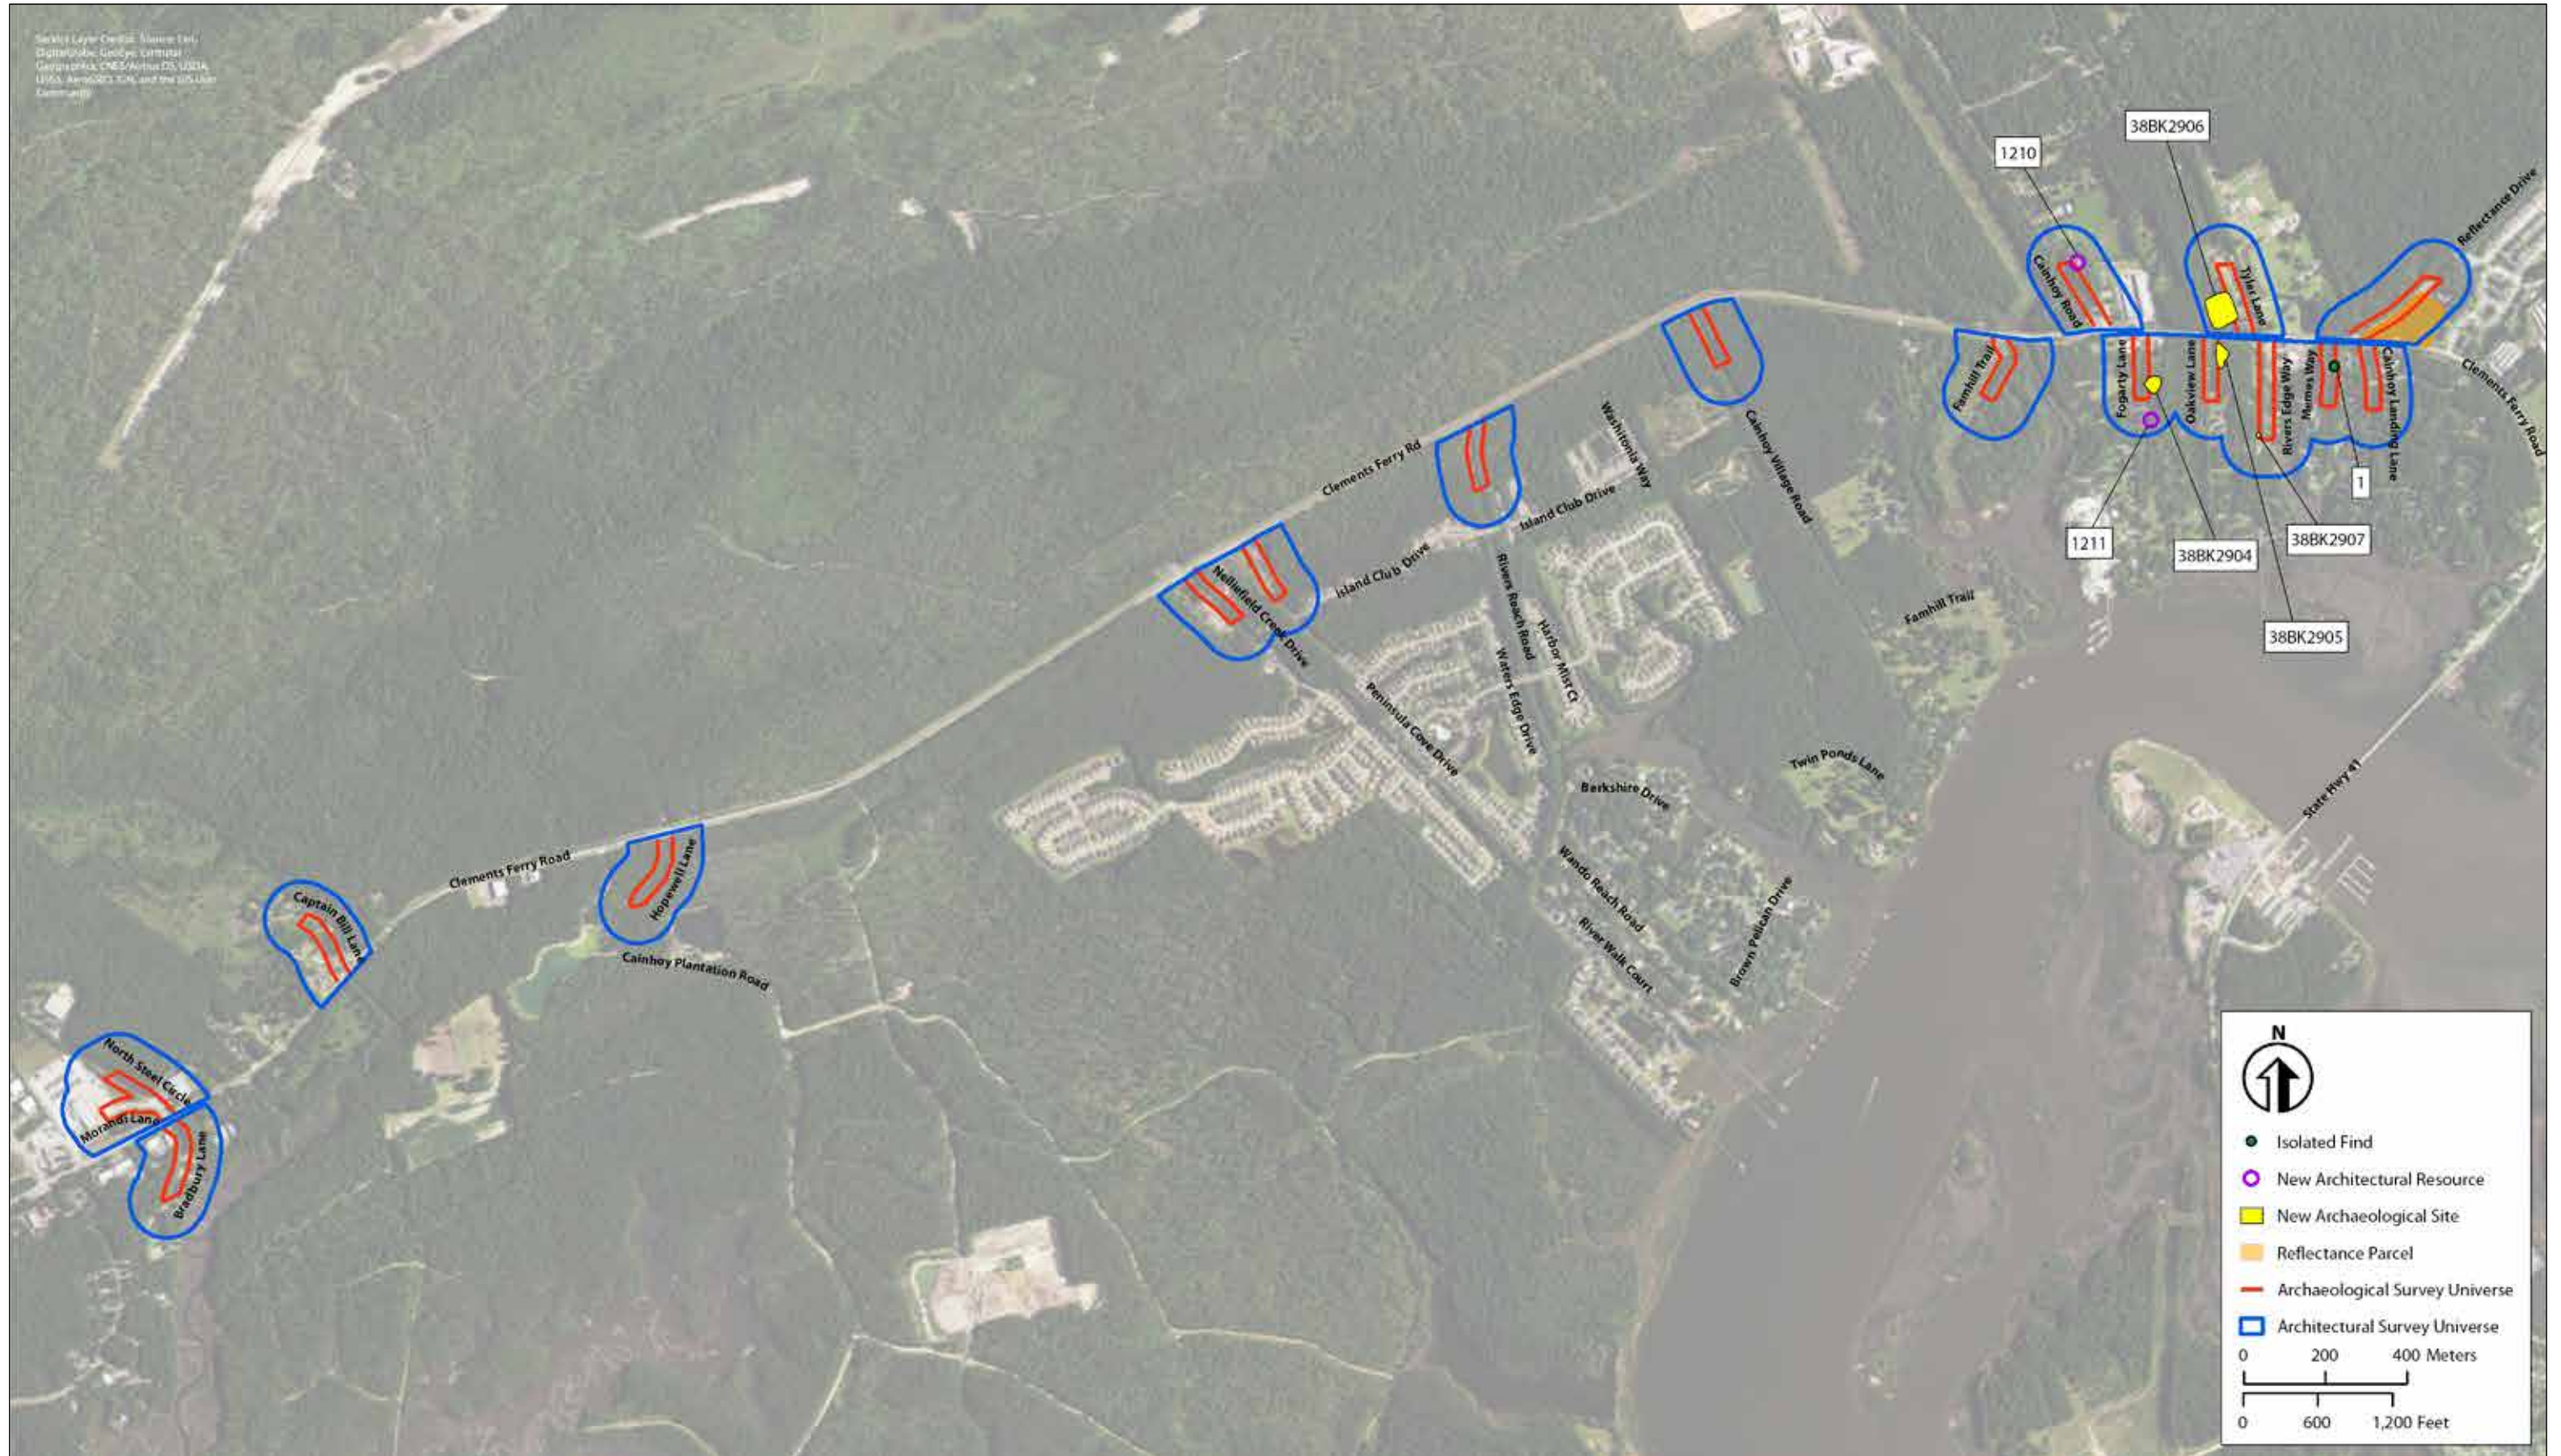
Figure 1.5 The location of the Clements Ferry Road Improvements Project and newly identified resources on a modern aerial photograph.

The archaeological survey universe extends 168 meters (550 feet [ft]) up the 14 side streets from the centerline of Clements Ferry Road and 18 meters (60 ft) from the centerline of each side street. During Fletcher et al.'s (2012) original survey investigations, the archaeological survey universe extended 30 meters (100 ft) to either side of the existing right-of-way (ROW) along Clements Ferry Road. During the current investigations, archaeological survey was accomplished through the examination of one shovel test survey transect to each side of each intersecting street. Each transect was generally placed 15 meters to each side of the intersecting side street. At the approximately two-acre Reflectance Parcel to the east of the intersection of Clements Ferry Road and Reflectance Road, the project archaeologist excavated shovel tests along transects spaced 30 meters apart. The project archaeologist excavated shovel tests at 30-meter intervals along each transect. Each shovel test measured approximately 30-by-30 centimeter (cm) in diameter and was excavated into sterile subsoil (usually 45-60 cm below surface [bs]). The fill from these tests was sifted through ¼-inch mesh hardware cloth. The project archaeologist excavated a total of 128 shovel tests. Visual inspection was conducted in areas with good ground surface visibility. Information relating to each shovel test and soil profile was recorded in field notebooks. All shovel tests were backfilled upon completion. Figure 1.5 presents the location of the project and newly identified resources on a recent aerial photograph.

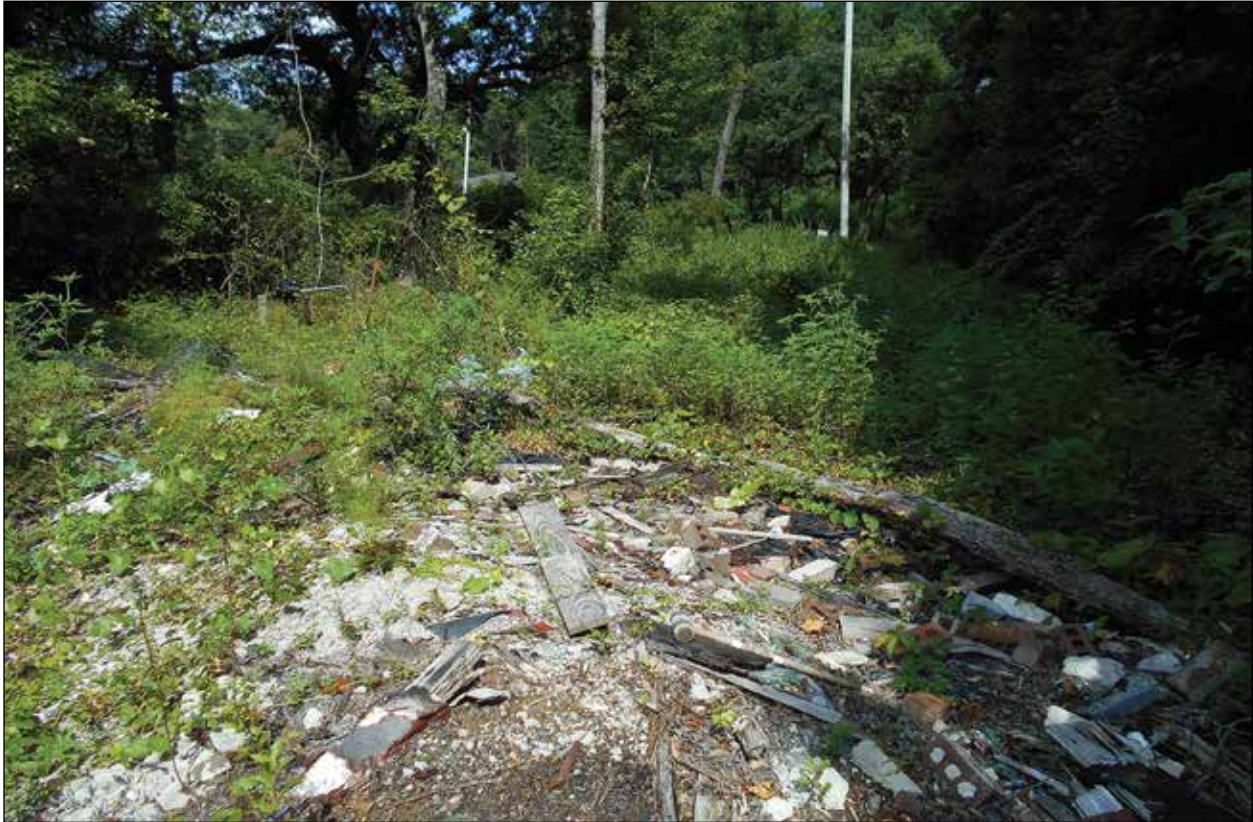
Figure 2.2 View of 38BK2904, facing east.

38BK2904 consists of a surface and subsurface scatter of twentieth-century artifacts and architectural remnants. The site measures approximately 35-by-85 meters and is located to the east of Fogarty Lane, within a transmission line corridor (see Figures 1.2 and 1.5). The site is bounded to the north by wooded wetlands and to the south by a house and manicured yard. The eastern and western site boundaries are defined by the extent of the surface artifact scatter. The site area is wooded in sparse hardwoods with a moderate understory of vines. Figure 2.1 presents a plan of 38BK2904. Figure 2.2 presents a view of 38BK2904.

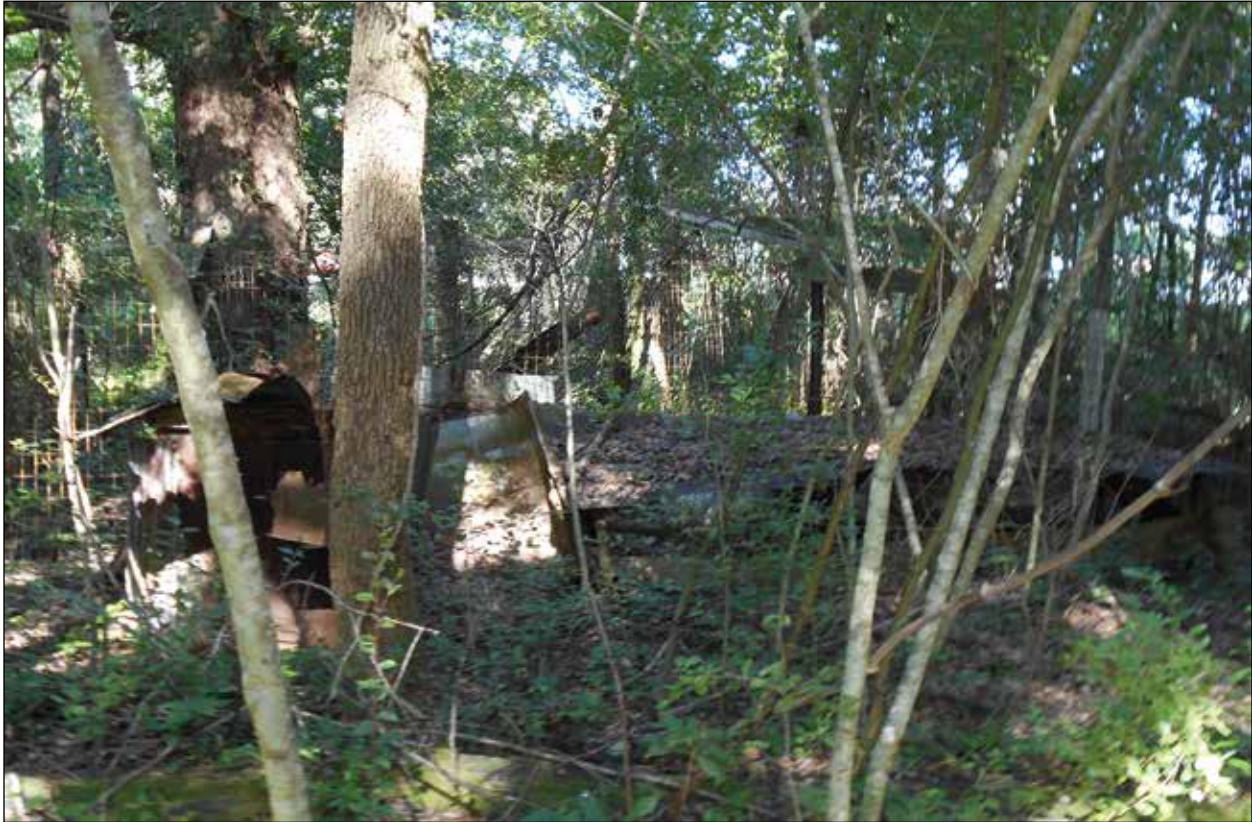
Figure 2.5 View of the animal pen at Site 38BK2905, facing east.

Site 38BK2905 consists of a subsurface scatter of nineteenth- and twentieth-century artifacts and architectural remnants. The site measures approximately 65-by-30 meters and is located to the southeast of the intersection of Clements Ferry Road and Oakview Lane (see Figures 1.2 and 1.5). The site is bounded to the north by Clements Ferry Road, to the east and south by privately owned wooded areas, and to the west by Oakview Lane. The site area is wooded in several mature hardwoods with a dense understory of small hardwoods. The remnants of a wood and wire mesh animal pen are located in the southern portion of the site. Figure 2.4 presents a plan of Site 38BK2905 and nearby Site 38BK2906. Figure 2.5 presents a view of 38BK2905.

though the area is obscured by tree cover (Historic Aerials Website n.d.). Based on the presence of largely nineteenth-century domestic artifacts and architectural debris, it seems that a house once stood in this area and was no longer present by 1943. Given the architectural debris and the remnants of a wood and wire animal pen, it appears that a house was present in the area by the late twentieth century and either burned or collapsed, with the majority of the materials being removed from the site area.

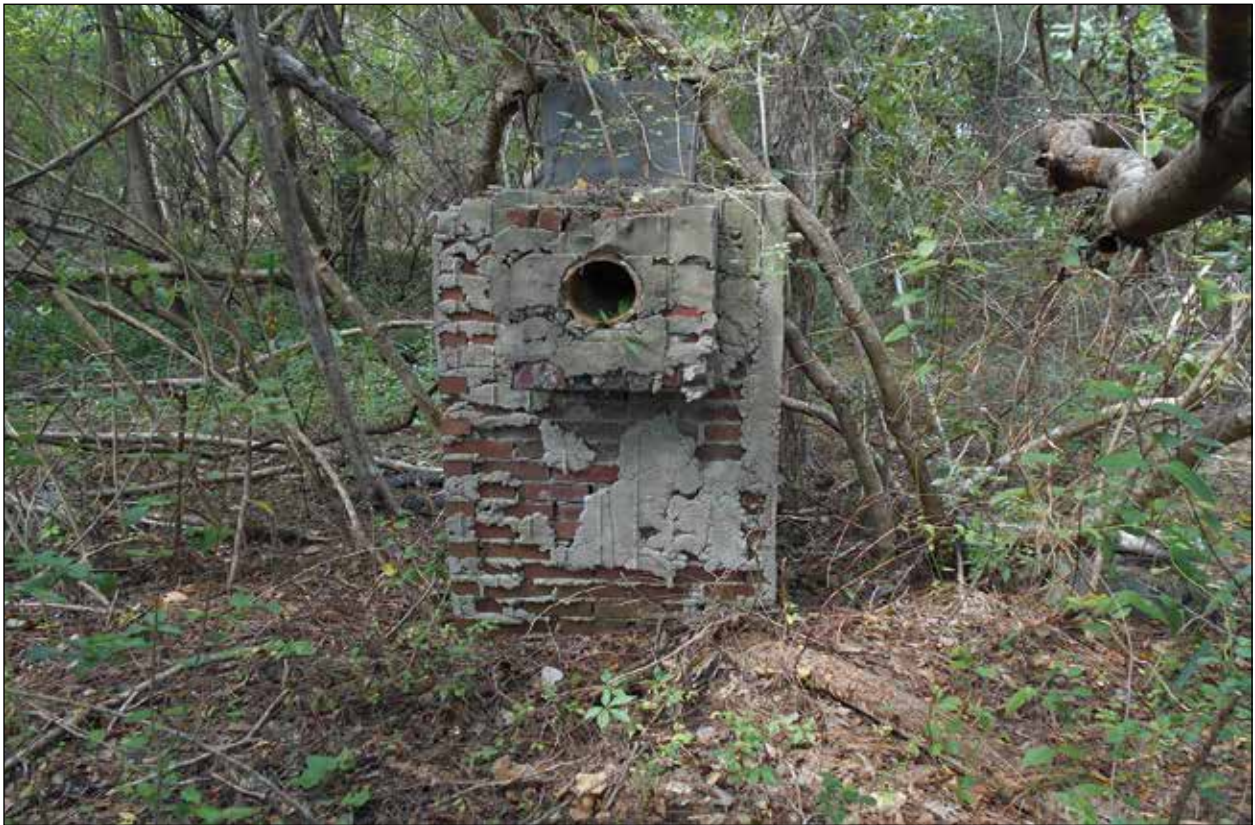
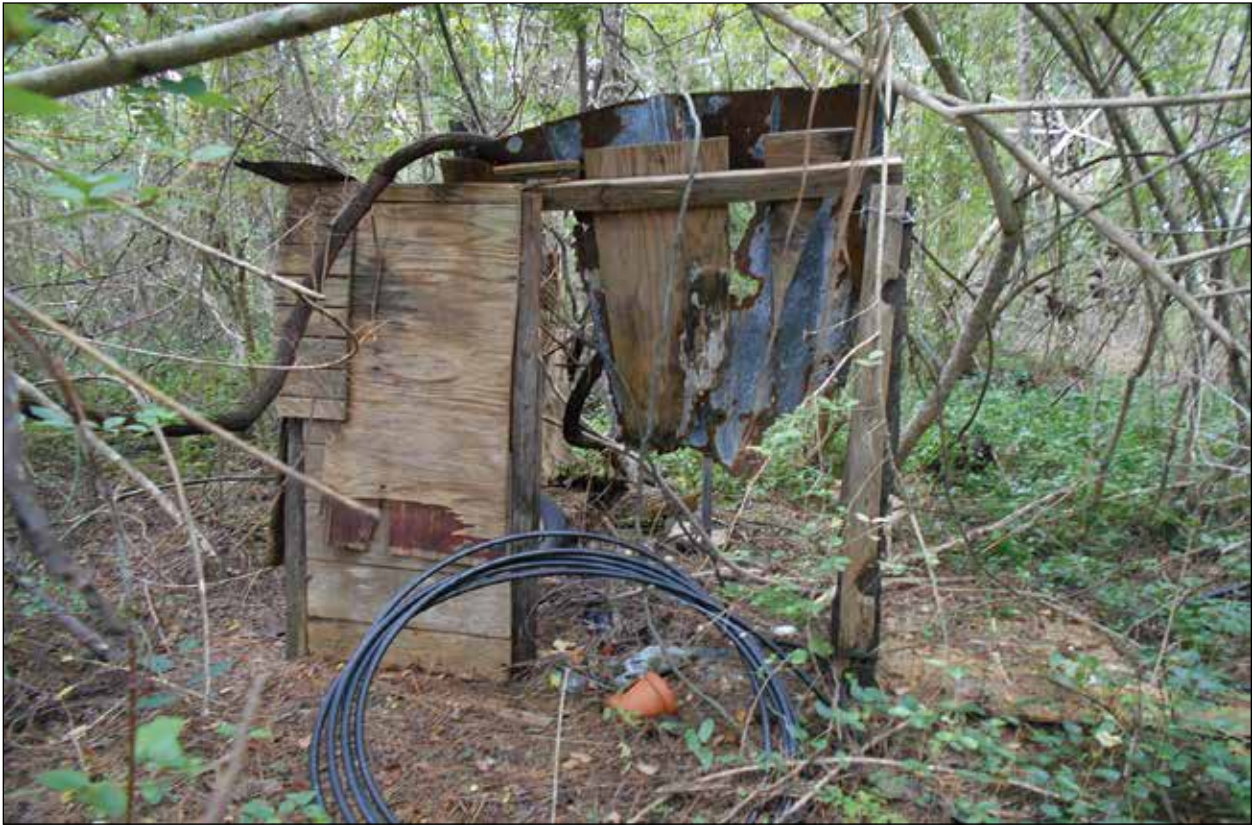
Figure 2.7 Views of Site 38BK2906: pier with chimney base, facing west (top); and outbuilding, facing west (bottom).

No structures are currently present in the site area. On the 1943 USGS quadrangle, Tyler Lane does not yet exist, but there is a structure depicted in the site area. By the printing of the USGS 1958/p.r. 1971 *Cainhoy, SC* quadrangle, Tyler Lane still does not exist, but there is no structure depicted in the location of Site 38BK2906 (Historic Aerials Website n.d.). Beginning with the 1957 aerial photograph, and continuing through the most recent 2013 aerial photograph, no structures are visible in the location of Site 38BK2906, though a house is located just north of the site, likely the house that still stands to the north of the site (Historic Aerials Website n.d.). Based on the presence of late nineteenth- to twentieth-century domestic artifacts and architectural debris, it seems that a house once stood in this area by 1943, but was no longer standing by 1957. The modern (possibly late twentieth century) standing concrete and brick piers, as well as the remnants of a wooden outbuilding, appear to have been constructed more recently than 1957, so this likely represents a fairly short-term occupation, ending when the house either burned or collapsed.

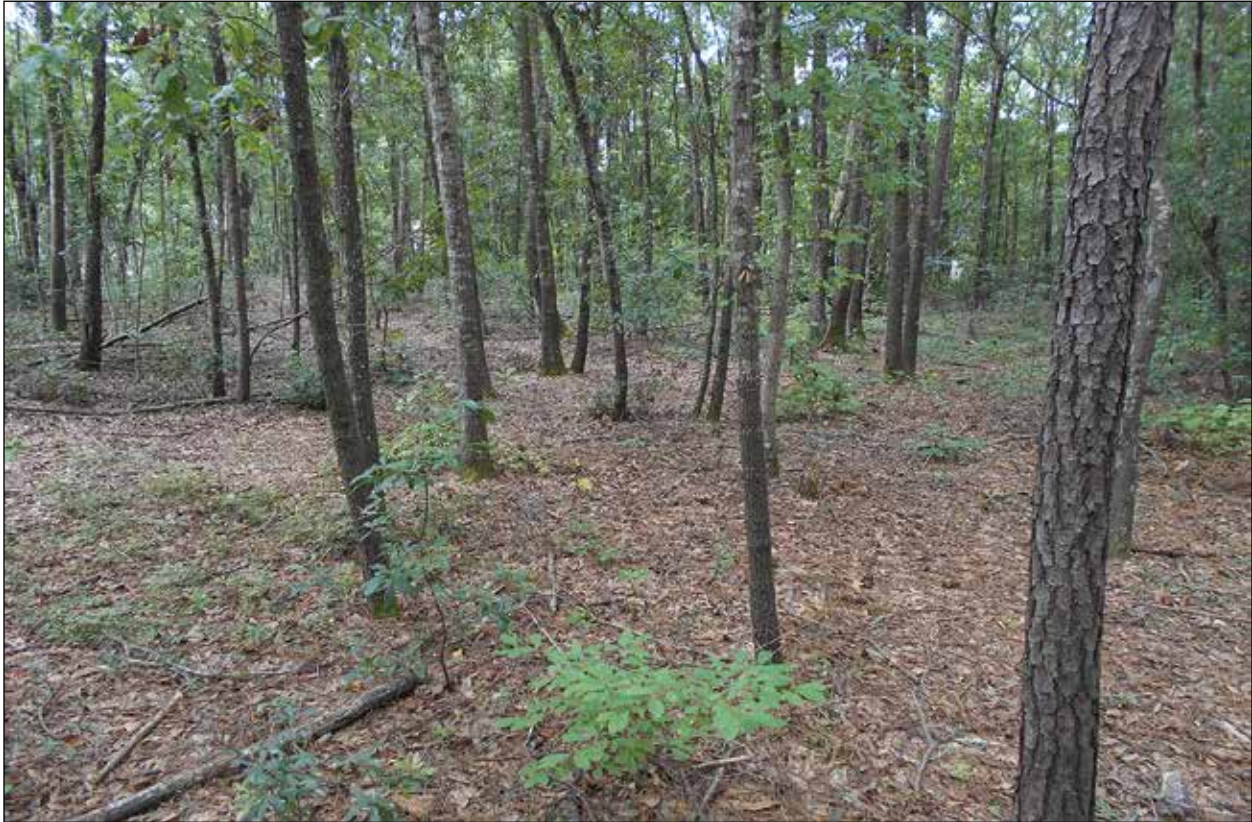
Figure 2.10 View of 38BK2907, facing west.

Site 38BK2907 consists of a small subsurface scatter of nondiagnostic Pre-Contact ceramic sherds and eighteenth- to nineteenth-century kaolin pipe stem fragments. The site measures approximately 7.5-by-7.5 meters and is located to the west of Rivers Edge Way (see Figures 1.2 and 1.5). The site is bordered to north and west by privately owned wooded areas, to the south by a house, and to the east by Rivers Edge Way. The site area is wooded in mixed pines and hardwoods. Figure 2.9 presents a plan of 38BK2907. Figure 2.10 presents a view of 38BK2907.

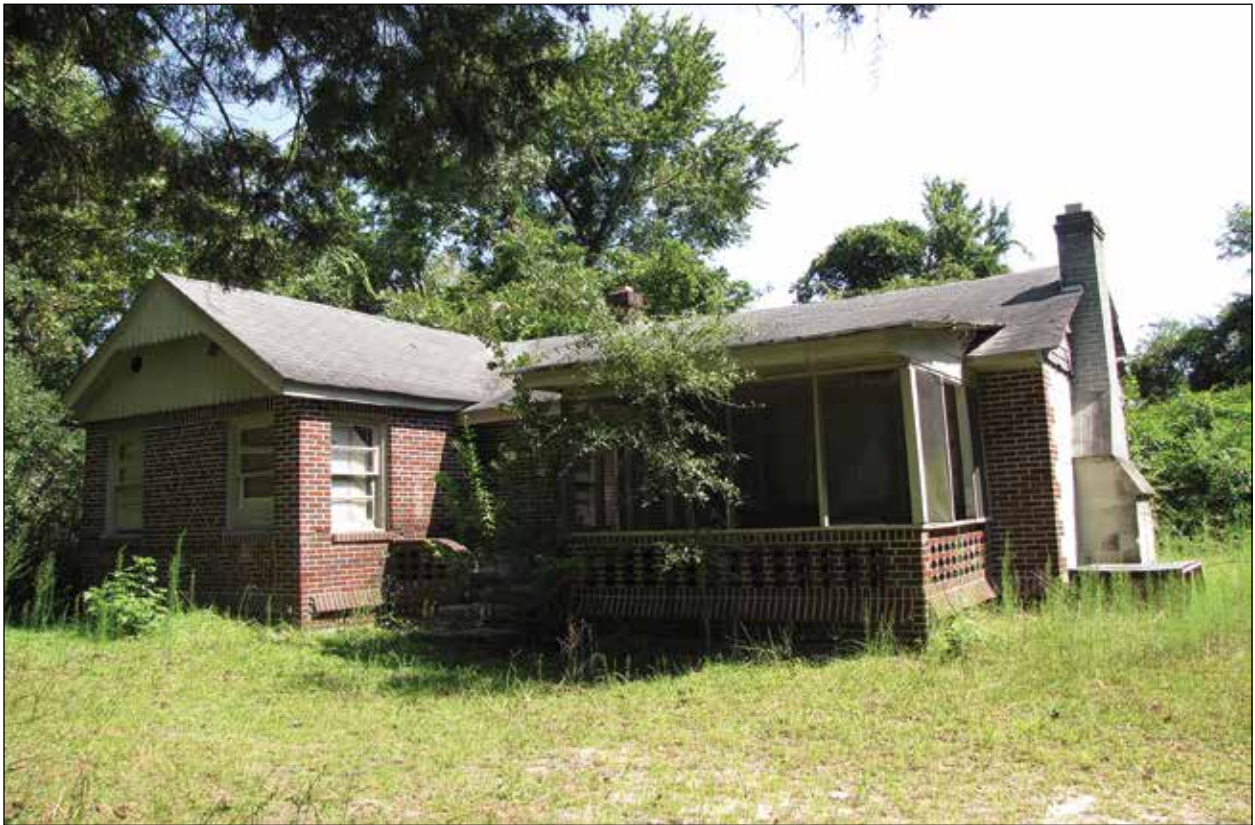
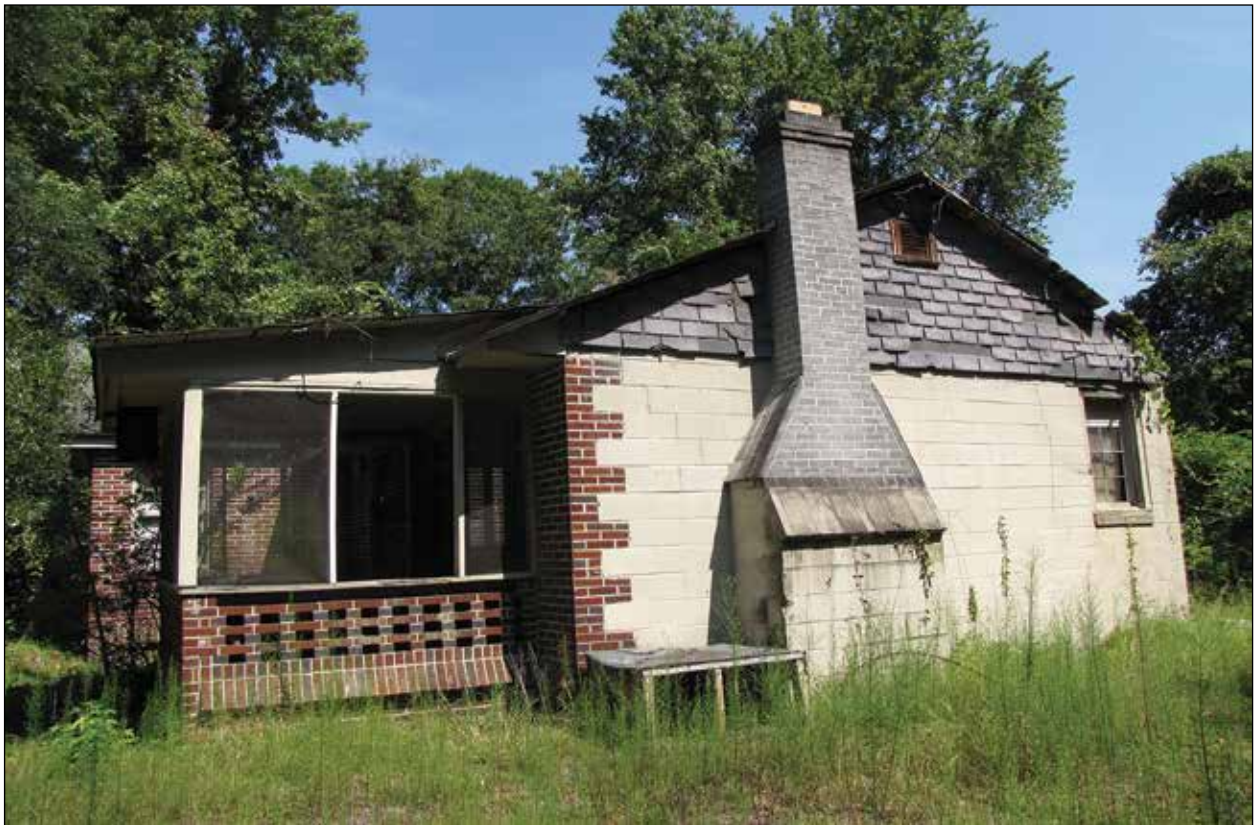
Figure 2.12 Views of Resource 1210: southeast oblique (top); south elevation (bottom).

Resource 1210 faces west at 1026 Cainhoy Road. It is a circa 1930 single-story house with a gable-front and wing form. The resource sits approximately 500 ft north of the intersection with Clements Ferry Road along a corridor of mixed commercial and domestic development. The roof is clad in composite shingles and features two chimneys: one on the south elevation and one in the wing roof line. The front gable has decorative vertical, wooden shingling hanging from the rake and the recessed surface of the gable. The wing gable has horizontal, composite shingles on the surface of the gable. The western (front) elevations are clad in brick veneer in a running bond pattern, while the eastern (rear) elevations are painted concrete block. The front elevations feature a flared brick, decorative watertable. The replacement windows are wooden, horizontal, two-over-two, and double hung. The front shed-roofed porch covers the wing portion of the front elevation and has been partially enclosed. The porch railings and balustrades are brick. The foundation was not visible, but is likely concrete block. Figure 2.12 presents views of Resource 1210.

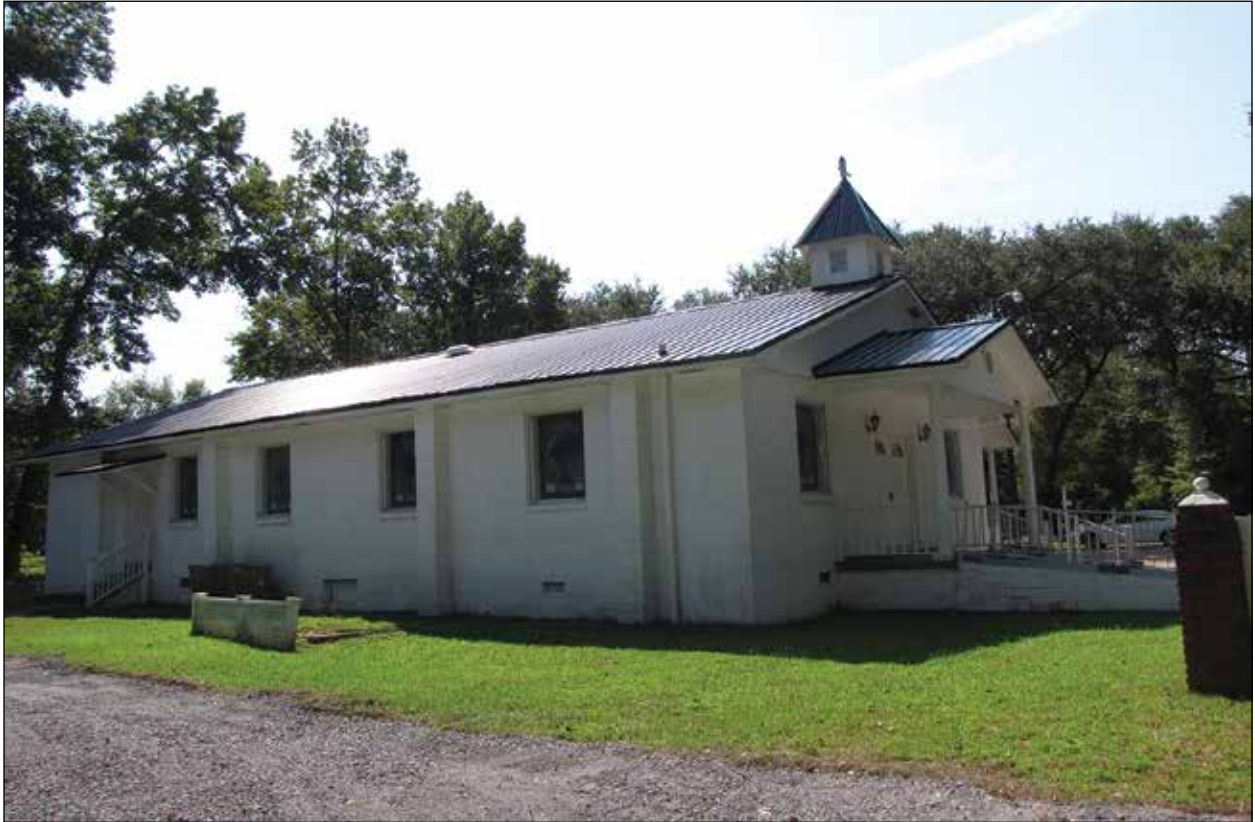
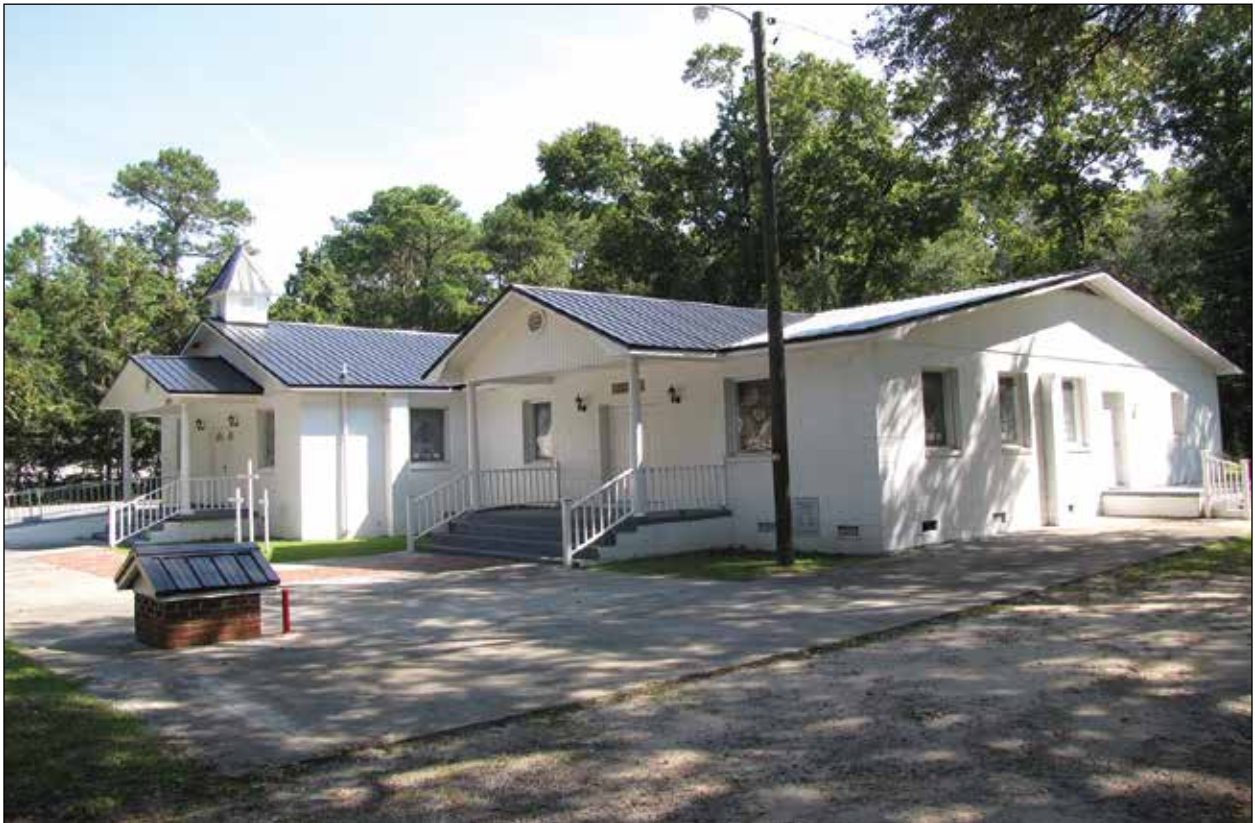
Figure 2.13 Views of Resource 1211: northeast oblique (top); southeast oblique (bottom).

Resource 1211, constructed in 1969, is a front-gabled vernacular church facing west at 1024 Fogarty Lane. It sits approximately 650 ft south of the intersection with Clements Ferry Road, along a corridor of mixed commercial and domestic development. The single-story concrete block building rises from a concrete block foundation. The windows are multi-pane, decorative stained-glass. The walls feature concrete block, gothic-style, decorative buttresses. The roof is clad in standing-seam metal. The projecting front-entrance gable is supported by round columns and features a round vent in the gable's surface. The double-doors of the entrance each feature a five-pane fan light over four panels. Concrete steps and a concrete ramp lead to the concrete slab foundation of the entranceway. The steps feature a modern-aluminum squared-railing; the railing that leads up the ramp is also aluminum, but appears to be removable.

There is a 1999 concrete block addition to the south elevation of the resource. The architecture of the addition mimics the main resource. The roof is cross gabled, with a round vent in the surface of the front-facing gable. The front gable is supported by plain, rounded columns. The double doors of the entrance feature six-panels. Concrete steps with metal railings lead to the concrete slab foundation of the entranceway. The windows are multi-pane, decorative stained-glass. The roof is clad in standing-seam metal. Figure 2.13 presents views of Resource 1211.
